## **Quarterly Report**

Project Title: "Understanding Magnetic Flux Leakage (MFL) Signals from Mechanical

Damage in Pipelines"

# TASK 11: Experimental MFL measurements and MFL modeling of gouges in full-scale pipe sections

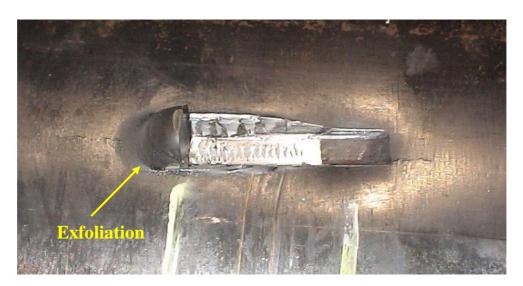
Figure 1: Photograph of Gouge # 5B installed at a pressure of 50% MAOP.

**Task # 11.5:** SES procured five full-scale 12.75-inch x 0.375-inch Grade X42 pipeline sections and welded end caps. Two gouges were installed 180° apart on each pipe, one at a pressure of 100% MAOP and the other at 50% MAOP, thus producing a total of 10 samples. A photograph of one of the gouges is shown in Figure 1. The length of each gouge was about 2-inches and the depth was varied from 0.100 to 0.500 inches from one pipe section to another. The detailed specifications of the gouges are given in Table 1 above. One of the pipeline sections was pressure cycled up to 1000 cycles, with MFL measurements made at specific intervals, as described below.
